# FIBER OPTIC MONITORING OF A NEW RAPID-SETTING, CURE-ON-DEMAND POLYMER RESIN FOR ROADWAY AND STRUCTURE REPAIR

Matthew Davis<sup>†</sup>, Tyler W. Farnsworth, Ph.D.<sup>†</sup>, Andrew Williams<sup>†</sup>, Eric Smith<sup>†</sup>, Alexander S. Brand, Ph.D., P.E.<sup>‡</sup>, T. Trevor Painter, M.S.<sup>‡</sup>

Keywords: Fiber Optic Sensing; Polymer Concrete Repair; SHM

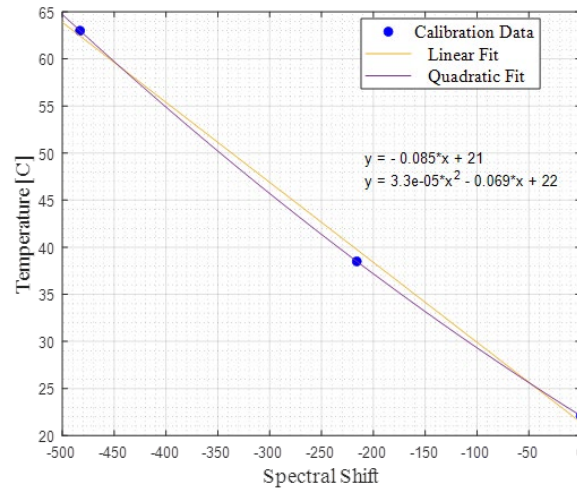
Figure 1. Temperature calibration of the ruggedized cable before installation into the test article

HD-FOS works on the principle of comparing the current dataset, or scan, to one that was taken during sensor manufacturing. As described by Kreger et al., the shift in the measured spectra vs the current spectra can be correlated to the strain or temperature applied to the sensor using a set of coefficients determined during a calibration process [10]. The cable used in this testing has calibration coefficients that were previously determined by Rahim et al. for the strain measurement [8]. A set of calibration coefficients valid between ambient and 65 °C for temperature measurement were determined prior to placement into the concrete by placing the sensor into an environmental chamber and stepping between ambient, 38 °C, and 63 °C and recording the spectral shift at those points. The same process was performed on a non-ruggedized sensor for comparison. Both a linear and quadratic fit were determined for the sensor and are shown on the plot in Figure 1.

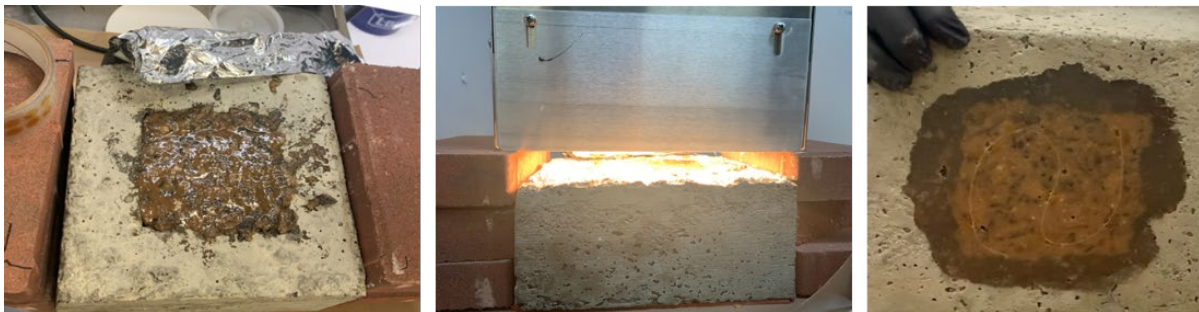
Figure 3. 4" x 4" x 4" prototype patch containing the ODiSI thermal sensing fiber, cured with the IR Heater. Image at right shows the bottom of the patch 1 hour after cure

Figure 2. Data produced by the ODiSI platform shows a temperature gradient along a fiber that was woven within the epoxy concrete patch. Fiber layers are spaced in 25 mm (1 inch) increments. As shown in Figure 2, the fiber optic sensor was able to successfully monitor heat flow through-thickness as a function of time and 3D space. Even after the IR heater was turned off, the exotherm continued, with the fiber optic sensors showing an equilibration point of ~60 °C at the 35 minute mark. After 1 hour, the patch was flipped over to assess the cure through-thickness. The bottom of the patch was cured to hardness and was extremely durable as shown in Figure 3.

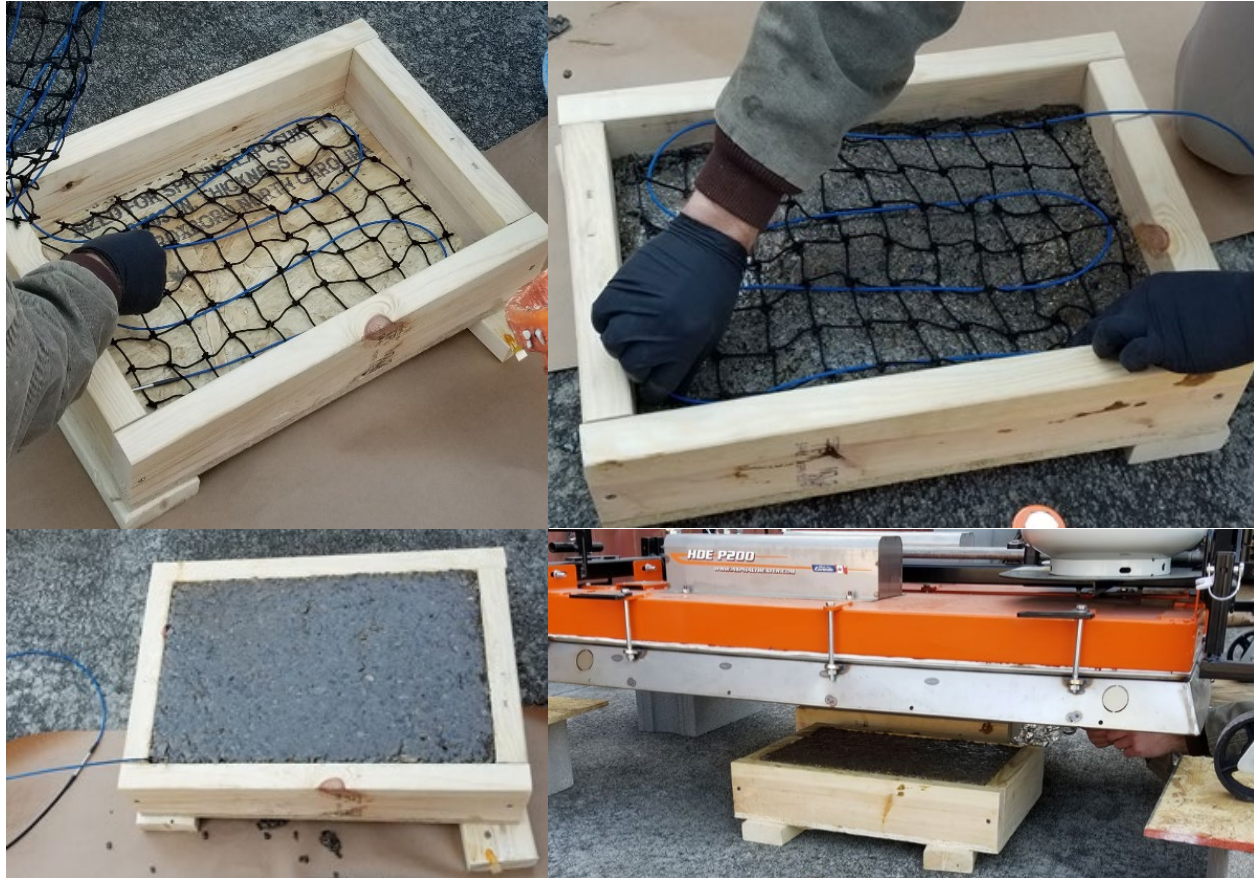
Figure 4. Incorporation of fiber optic within repair patch

The initial prototype cube was scaled to a 304 x 457 x 101 mm (12 x 18 x 4 inch) thick specimen that would simulate a repair patch. As shown in Figure 4, ruggedized fiber was carefully woven into a nylon net was placed in a two-tiered arrangement at the bottom and middle sections of the patch. The epoxy concrete was poured and tamped around the fiber, ensuring good packing of the resin and aggregate around the fiber. Following surface finishing, the concrete patch with incorporated fiber was cured top-down using a propane-powered IR heater.

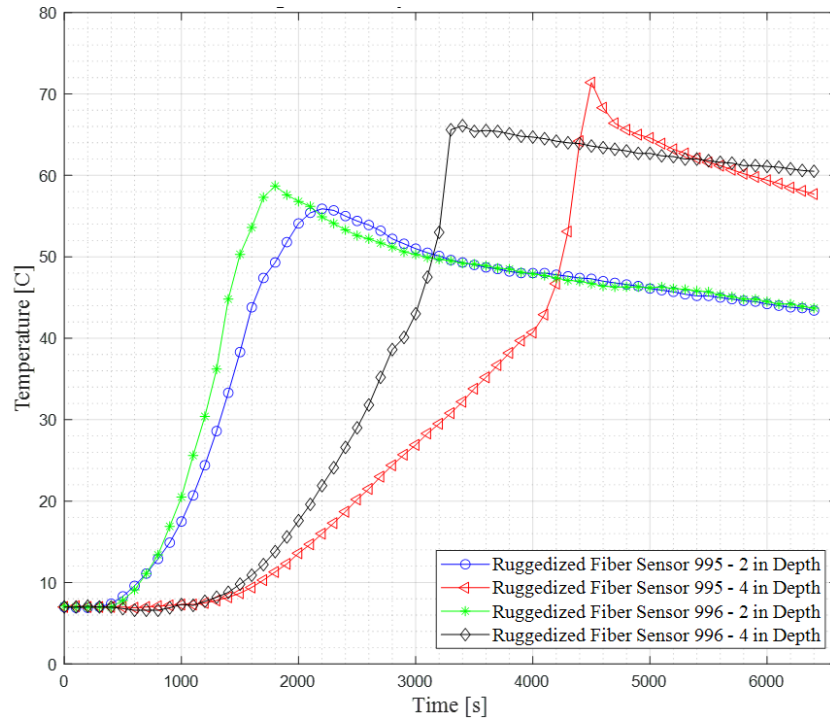
Figure 5. Temperature measurements using a reinforced cable during test article curing

The patch temperature was monitored using the ruggedized cable and it was observed that the maximum temperature exceeded the calibration. While the fiber was not damaged, the results were not consistent with the readings from thermocouples that were also embedded. This demonstrated that while the rugged cable was suitable for monitoring the strain on the patches once they had been cured, it would not be suitable for monitoring the temperature of the patches during the curing process. The data from the ruggedized cables used for this cure can be seen in Figure 5. Once the temperature exceeded  $\sim 60$  °C the cable relaxed and provided a lower than expected measurement. Plots of the thermocouples are presented in Figure 6.

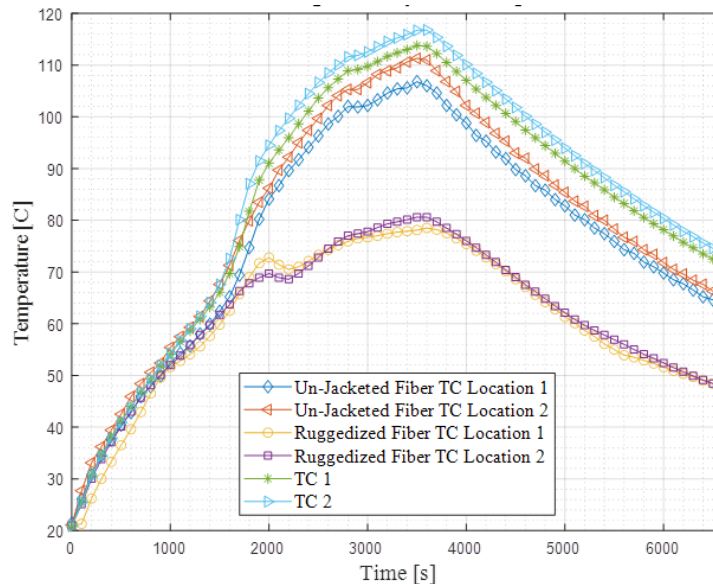
Figure 7. Temperature calibration of the standard [un-jacketed] fiber sensor, ruggedized fiber, and thermocouple (TC) using a 76 x 76 x 305 mm (3 x 3 x 12 inch) concrete prism. The polymer concrete was oven cured at 100 °C for 1 hour.

The use of the standard temperature sensors as a method of monitoring the cure process was validated during a test which compared the standard fiber temperature sensor to the ruggedized cables. Thermocouples were also included to provide a baseline temperature measurement. Two each of the standard fiber sensors, ruggedized fibers, and thermocouples were placed into a 76 x 76 x 305 mm (3 x 3 x 12 inch) polymer concrete prism. The concrete cure was initiated by placing the sample in an oven set to 100 °C. During the cure, the temperature readings of the standard fiber sensor and ruggedized fiber sensor were within 6% of the baseline thermocouple reading. This is considered to be good alignment given the ability to co-locate the fiber sensors. At 65 °C, the ruggedized sensor began to provide significantly lower readings due to the softening of its coating above the maximum-rated glass transition temperature of the fiber's protective coating. However, the thermocouples and the standard fiber sensors exhibited a sharp slope above 65 °C as the cross-linking exotherm was initiated. The temperature began to plateau around 85–90 °C before reaching a peak at approximately 115 °C. More investigation is needed to determine if the slope at ~65 °C corresponds to the beginning of the exothermic reaction and crosslinking points for the polymer resin.

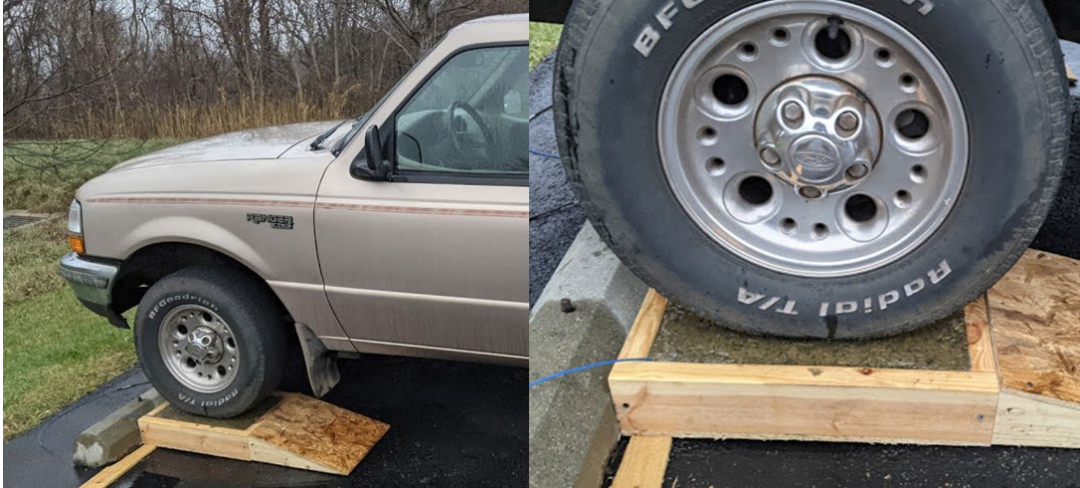
Figure 8. Vehicle 1 sitting on patch for 9 hours/day, 5 days/week.

The monitoring of the two patches was conducted by periodically scanning the fiber using an ODiSI 6100 Series optical interrogator and comparing the resulting strain measurements over time. Each day during the test period a vehicle with a minimum front axle weight of ~ 816 kg (1800 lb) (Vehicle 1) was parked on the test articles for approximately 9 hours. On days where a heavier vehicle (Vehicle 2) with a front axle weight of ~1590 kg (3500 lb) was available, the team would remove the lighter vehicle and conduct five (5) roll-on–roll-off cycles with the heavier-weighted vehicle while simultaneously monitoring the patch strain with the fiber sensor.

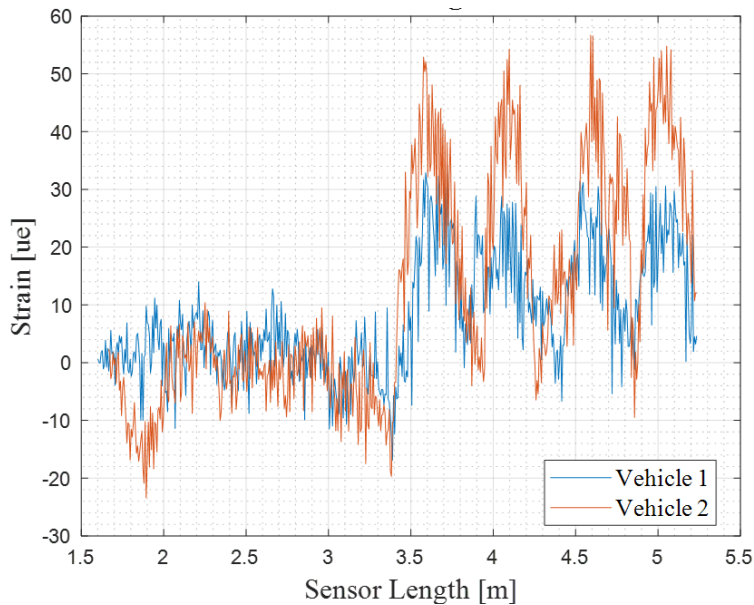
Figure 9. Strain measured by the sensor for both vehicles as a function of the sensor length

Figure 9 shows the strain profile of both vehicles both as a function of sensor length. The peaks in the plot indicate the locations where the most strain was observed, correlating to the top center of the test article. The section on the left of the plot is the portion of the sensor closer to the neutral axis, and hence experiences less strain. Due to the small strains that the team could place on the test articles, minimum change over time due to fatigue was expected at the time of writing this paper. It can be noted that the heavier vehicle induced roughly 50% more strain on the test article.
